Site: **Parkland Heights**
4929 Issaquah-Pine Lake Rd. SE
Issaquah, WA 98029
TPN: 2224069039
Parcel size: 230,925 sq. ft = 5.3 acres

Re: RFI all corrections and additions are highlighted in **yellow**

Thank you for requesting my services. On January 5th, 2022, I performed a Level 2 Tree Risk Assessment (TRA) for all significant* trees growing on the site above, as well as the ROW trees and those trees located offsite with canopies that overhung the property.

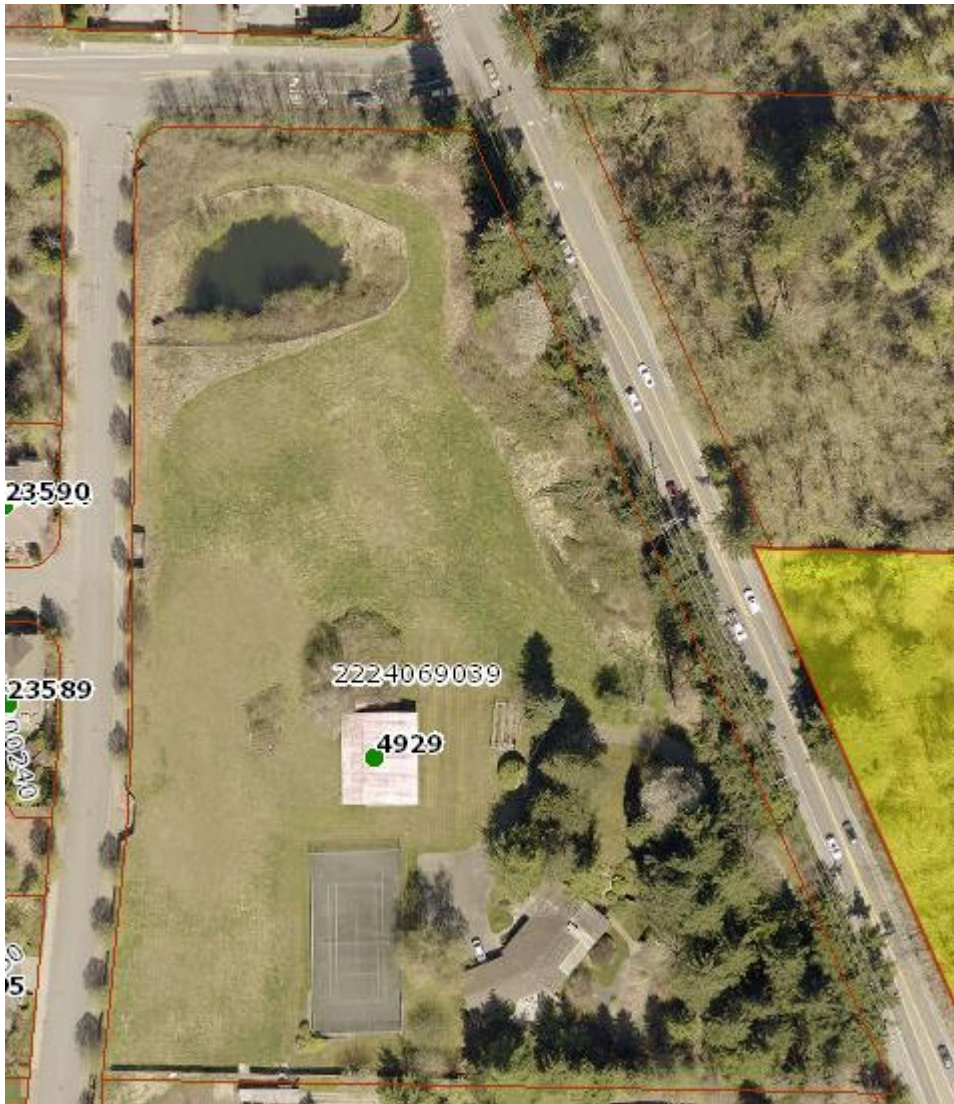
Site:

The Maclean Project (**now Parkland Heights**) is a 5.3-acre site located west of Issaquah/ Pine Lake Road in Issaquah. The parcel is accessed from the east by an asphalt drive up to a single-family residence located on the south side of the property. the parcel has a grove of trees located between the home and Issaquah Pine Lake Road; the remainder of the site has been cleared as pasture.

It appears Issaquah Pine Lake Road was constructed by excavating a steep hillside. The hillside is not constrained by a retaining wall and in some places the soil has been undermined by weather. Over the years trees have volunteered in the area whose growth has been "maintained" by the utility department. Many of the trees are now at high risk of failure, growing on a bank of soil, undermined by weather, and topped by utilities. For this reason, I deemed some trees located where it was too hazardous to individually tag. Those trees are identified on the spreadsheet with the tag location identified on surrounding trees.

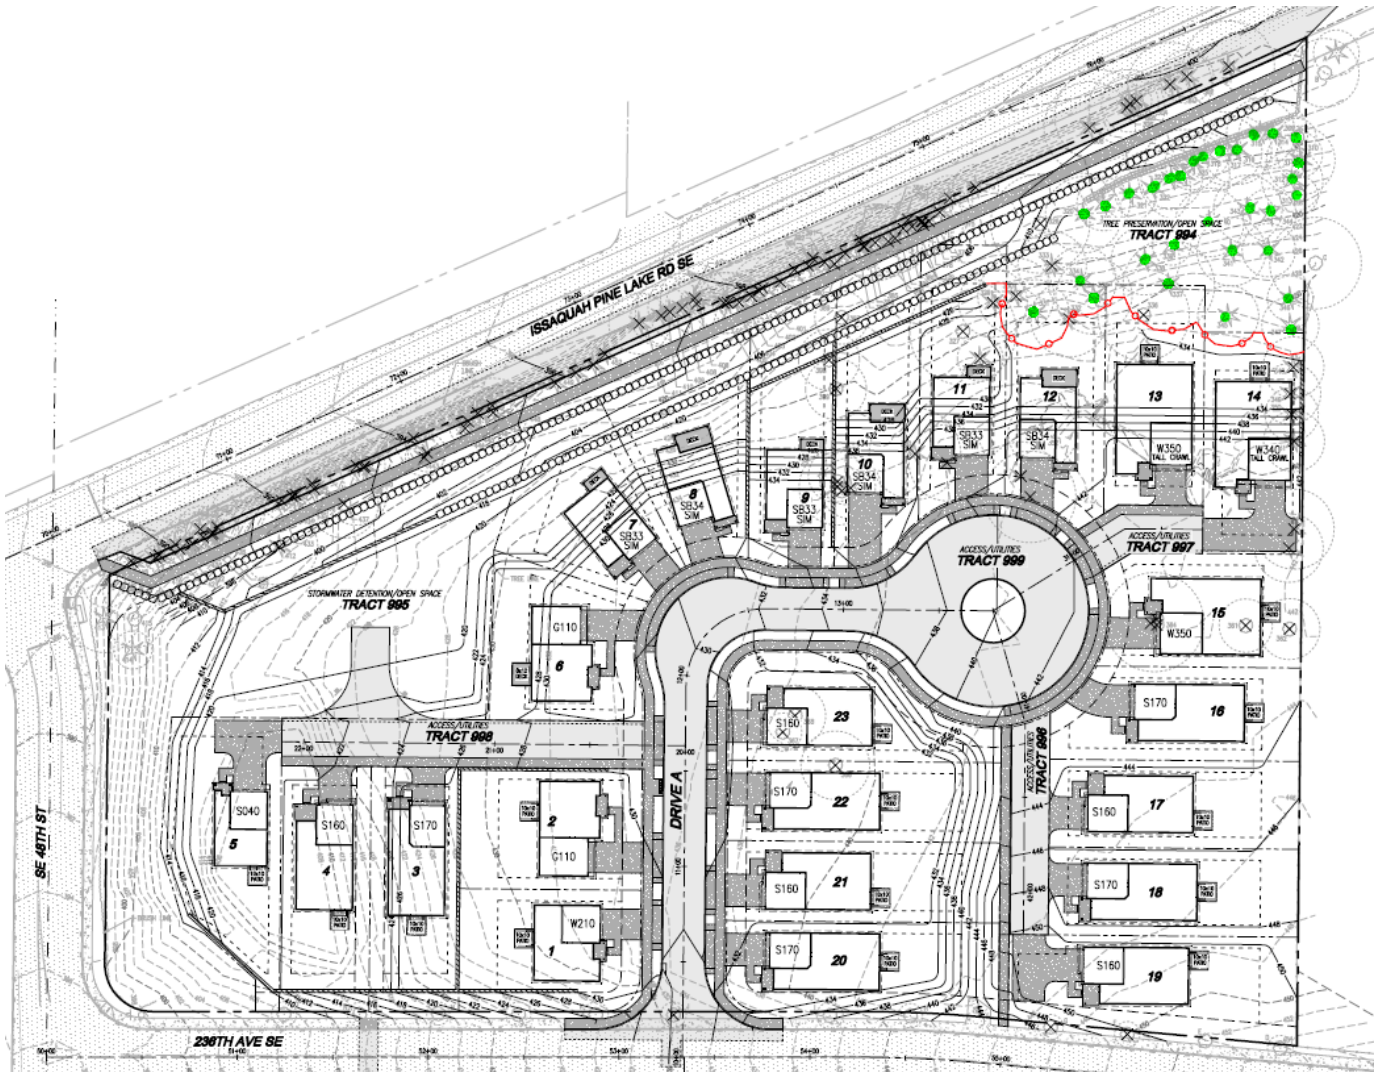
Proposed site improvements:

Proposed improvements include demolishing the existing home, garage and outbuildings and grading the site, and dividing the acreage into twenty-three (23) new single family residential lots. There is a new access proposed from the west.

Most of the viable trees are located on the SE corner of the site which will be maintained as a tree tract. The non-viable trees in this area can be retained (without credit) as habitat trees, however, at the conclusion of the build out the trees should be reassessed to ensure that they do not present a risk to traffic, pedestrians, or new homes; if they do so, they can be reduced in height to mitigate that risk.

Almost all of the trees on the eastside of the property next to the road are non-viable, those that are not, are proposed to be removed; the east side of the property will include new two retaining walls to adequately constrain the slope.
